*Engineers Australia  
Engineering Heritage Victoria  
Nomination*

# **McKILLOPS BRIDGE**

**OVER THE SNOWY RIVER**

**APRIL 2019**

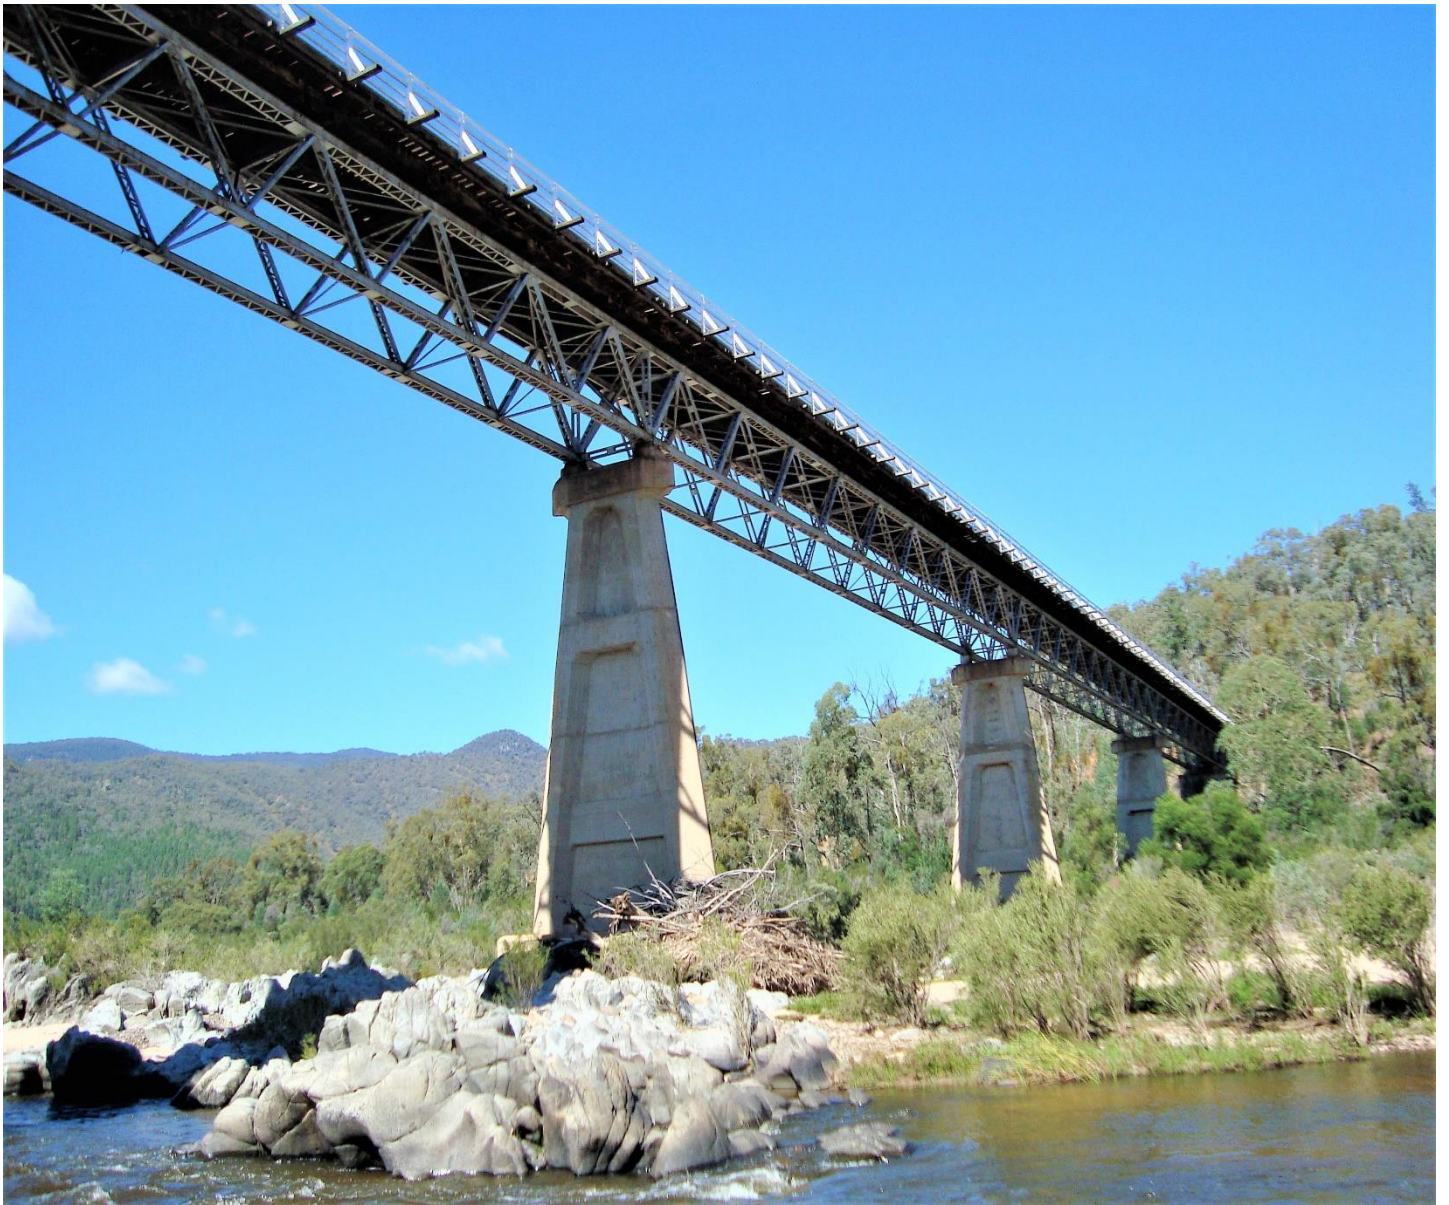
**McKillops Bridge looking towards the western abutment with the Turnback Track in the background.**

**This image was taken on 13 March 2010 with my trusty Nikon D90 standing right on the eastern bank of the river which is a very low level after the summer. The pier in the centre of the image is the Central Pier, the only one to which the bridge truss is attached and the one that failed in when the original bridge was washed away on 8 January 1934. The river is flowing from right to left.**

**Note that in this image there is some debris resting against the upstream face of the pier. Such debris is the Achilles Heel of this bridge but it has stood strong against many floods, with their debris since it was opened in December 1935.**

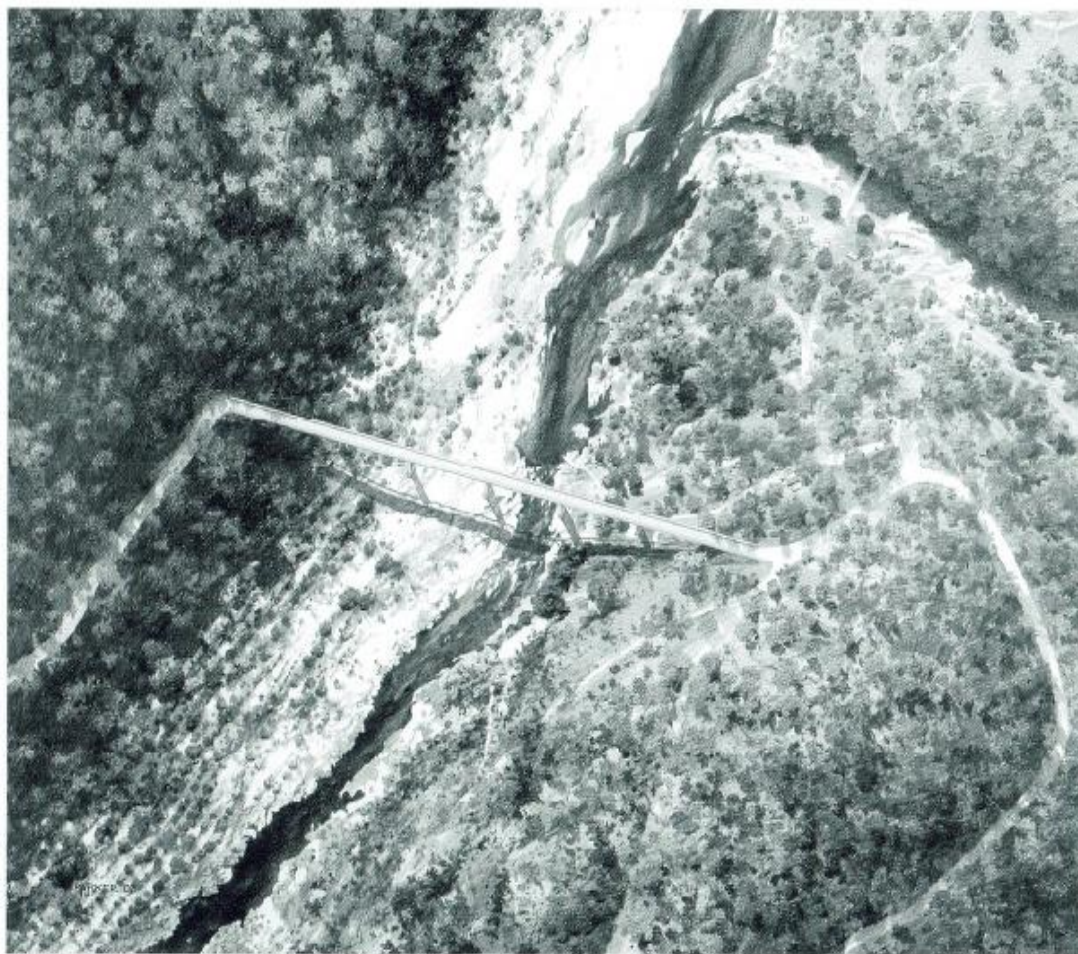
10. 450 x 570 mm, graphite pencil on CA grain paper

**Drawing by Kevin Parker of McKillops Bridge as if taken from a drone. The Snowy River runs from top (north) to bottom (south) in this drawing. The left hand side of the drawing is the western approach to the bridge. The Deddick River is in the extreme top right hand corner. With permission from artist Kevin Parker.**

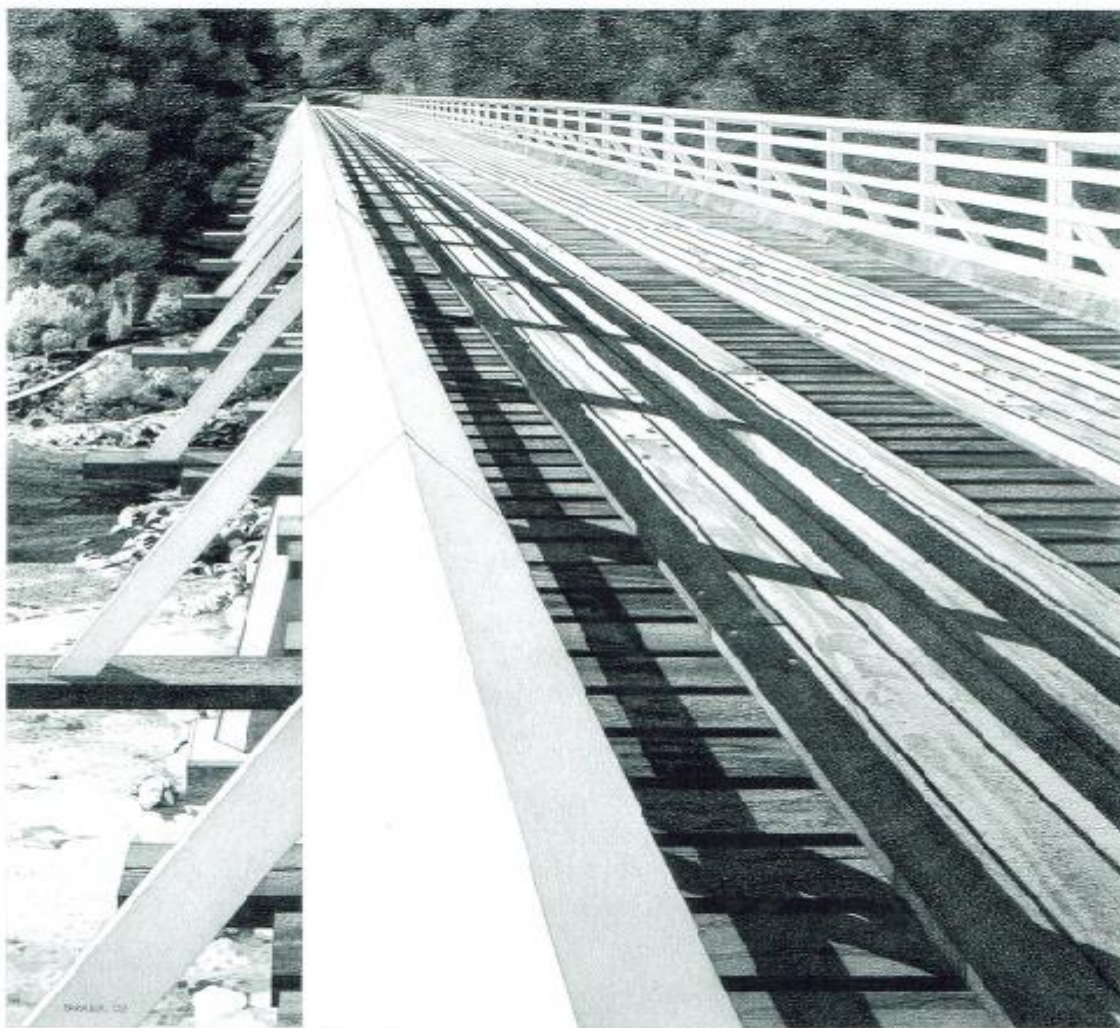
15. 510 x 420 mm, graphite pencil on CA grain paper

**Drawing by Kevin Parker of McKillops Bridge showing the deck. The northern handrail is prominent and the two sets of running strips can be seen in the roadway laid over the transverse decking.  
With permission from artist Kevin Parker.**

More detail of the construction is at Appendix 2. The drawing on the next page shows the deck from above.

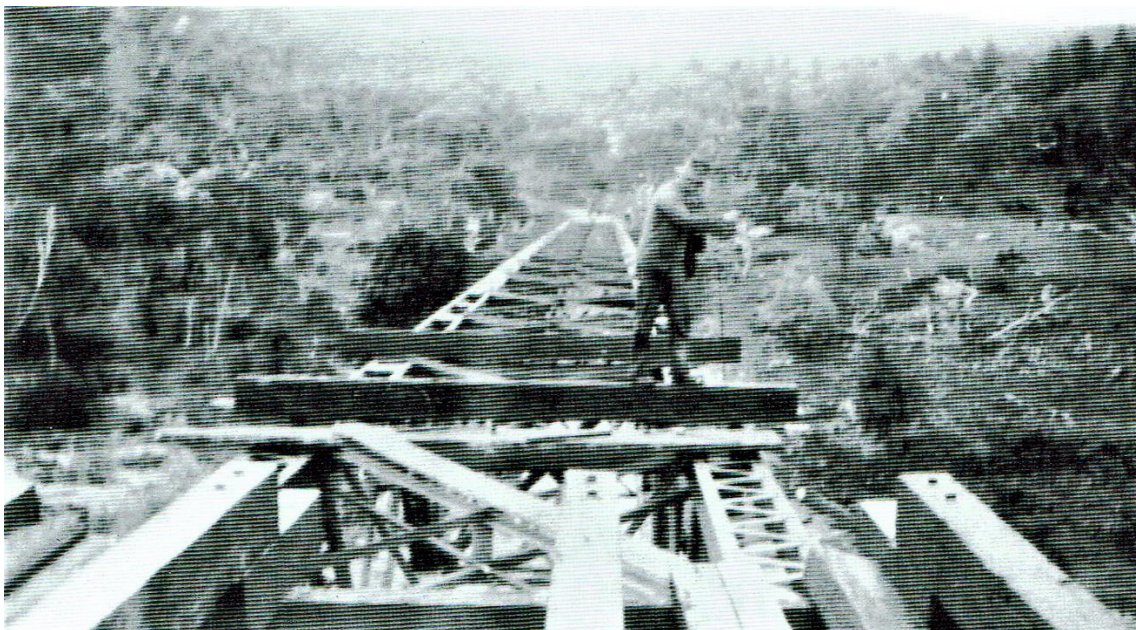
**Drilling holes for attachment bolts in heavy timbers for the deck.  
Image: Taken from Rhonda Coates, McKillops Bridge. Image by Reidy Family.**

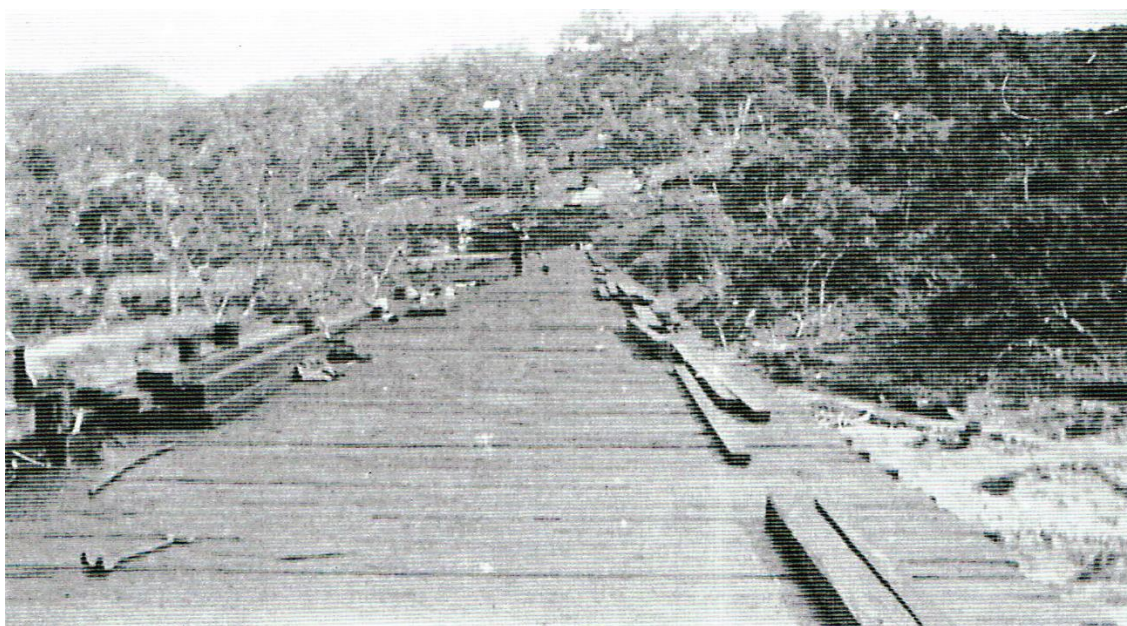
**The deck takes shape. Note the safety provisions at the edge of the deck.  
Image: Taken from Rhonda Coates, McKillops Bridge. Image by Helen Neven.**

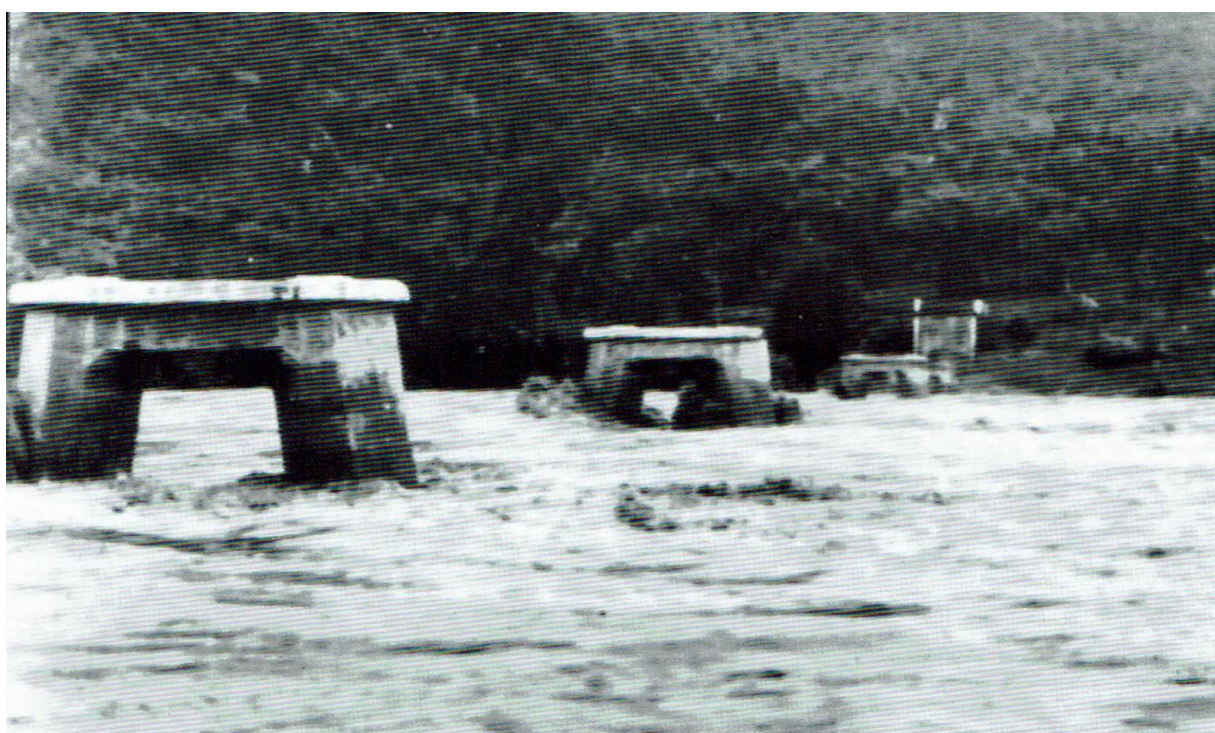
**The remains of the bridge after the trusses and deck were swept away on 8 January 1934. At the time of this image being taken the river level had reduced from its maximum level.  
Image: Taken from Rhonda Coates, McKillops Bridge. Image by Mona McLeod.**

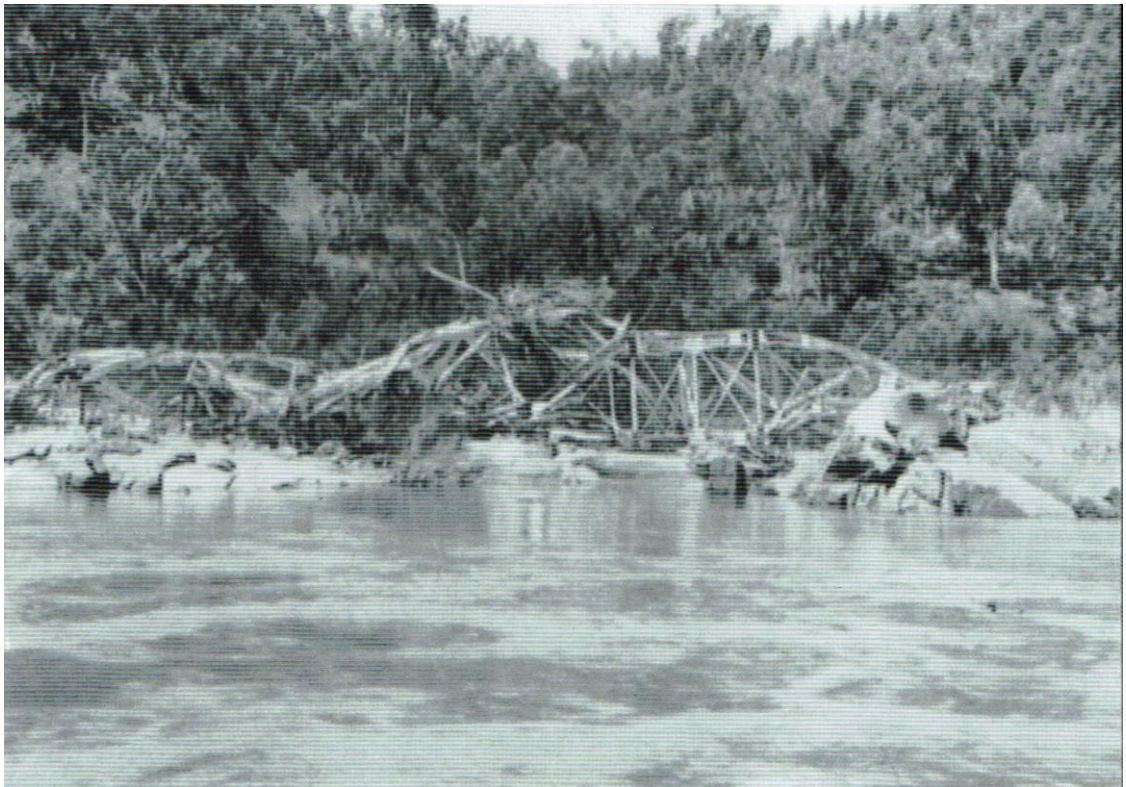
**Twisted remains of the bridge trusses and deck in the river bed some hundreds of metres downstream from the bridge site.**

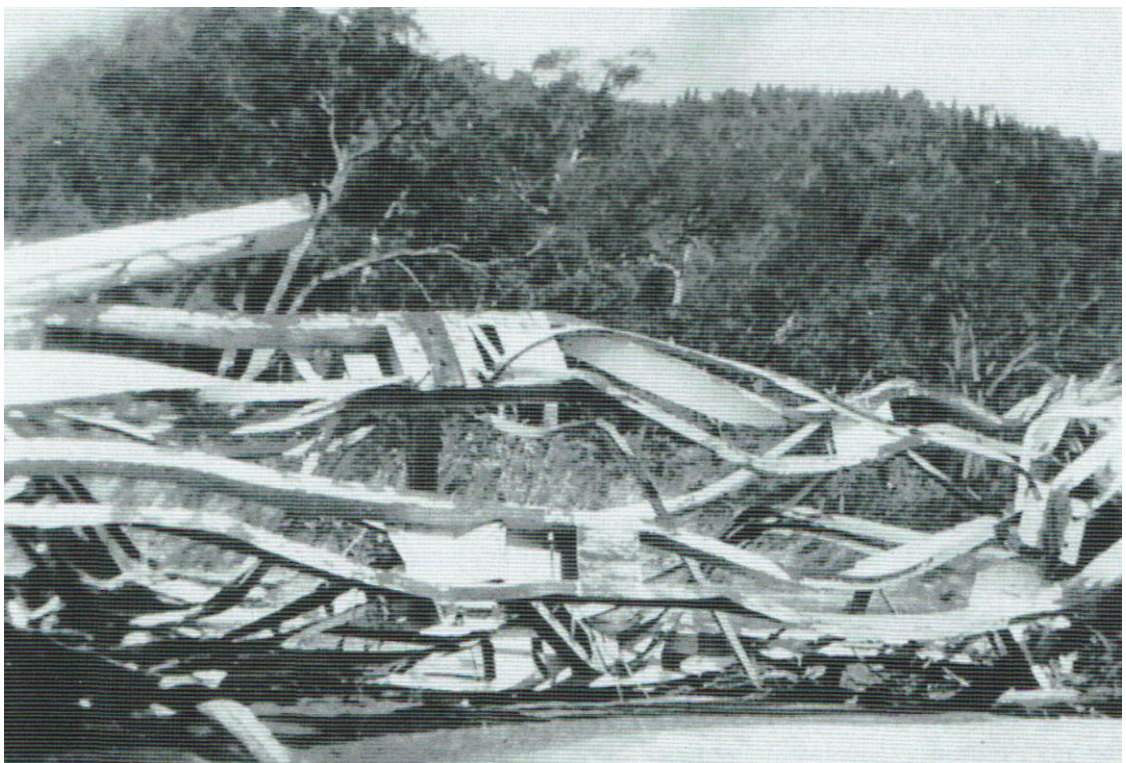
**Detail of twisted remains of the bridge trusses showing the forces inflicted by the river.**

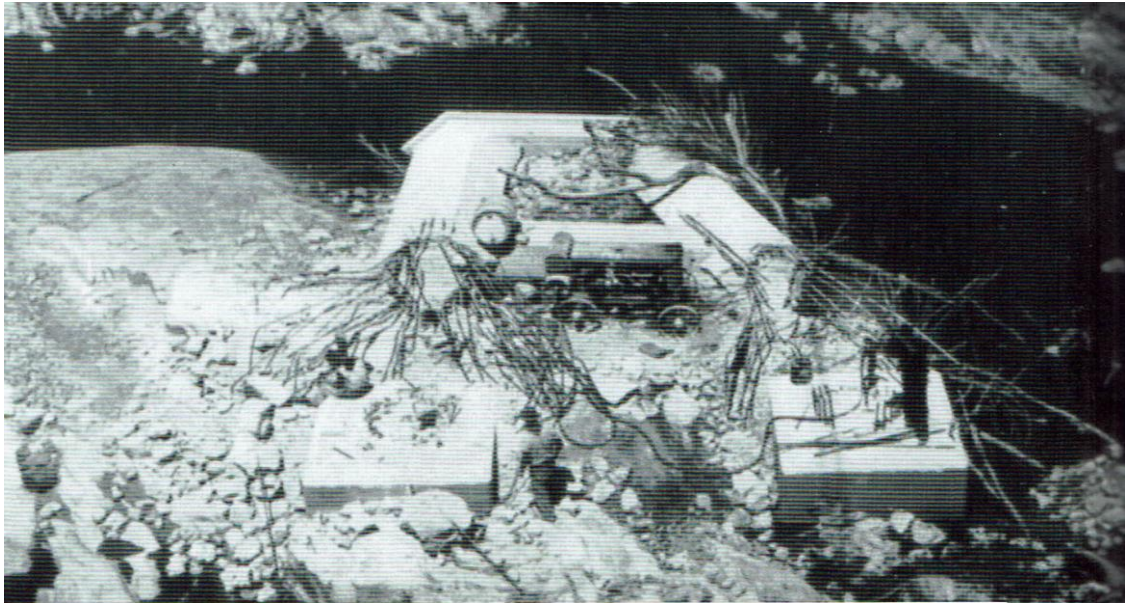
**Remains of the centre pier after the collapse.**

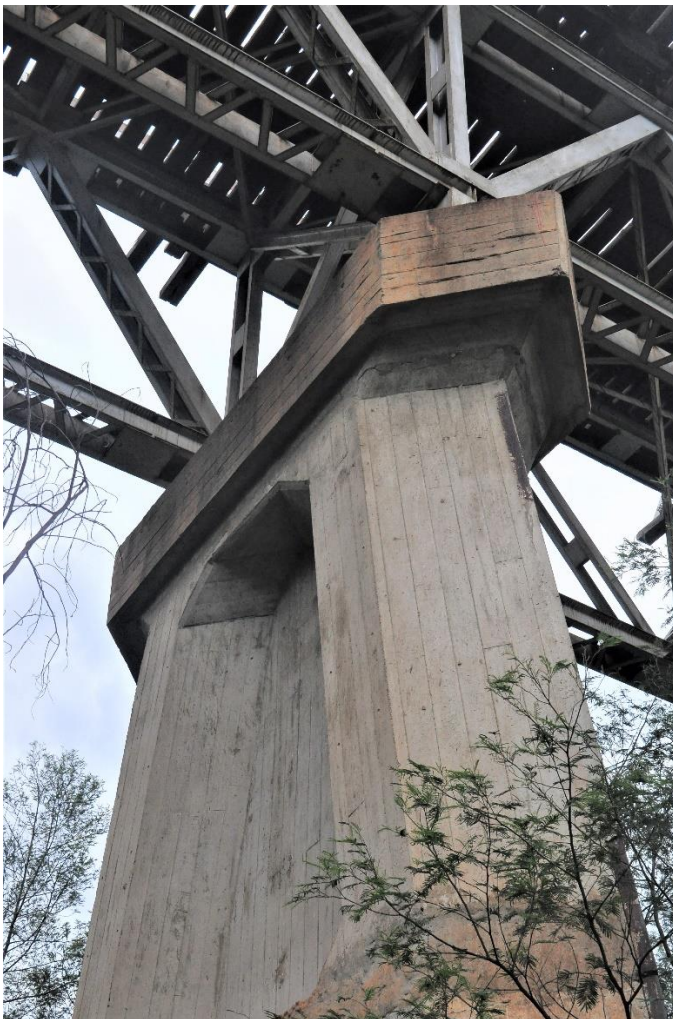
**McKillops Bridge. Close up of pier and trusses. The pier is the most easterly pier viewed from the upstream side.**

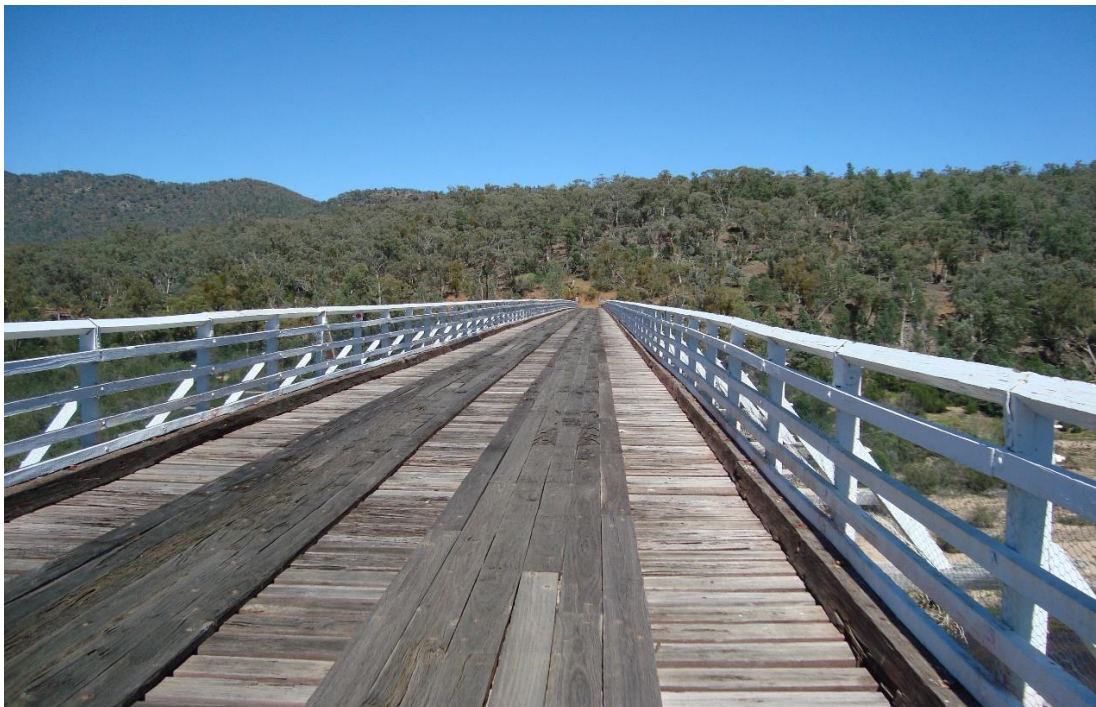
McKillops Bridge deck in 2010. Note running strips. Image: Owen Peake.

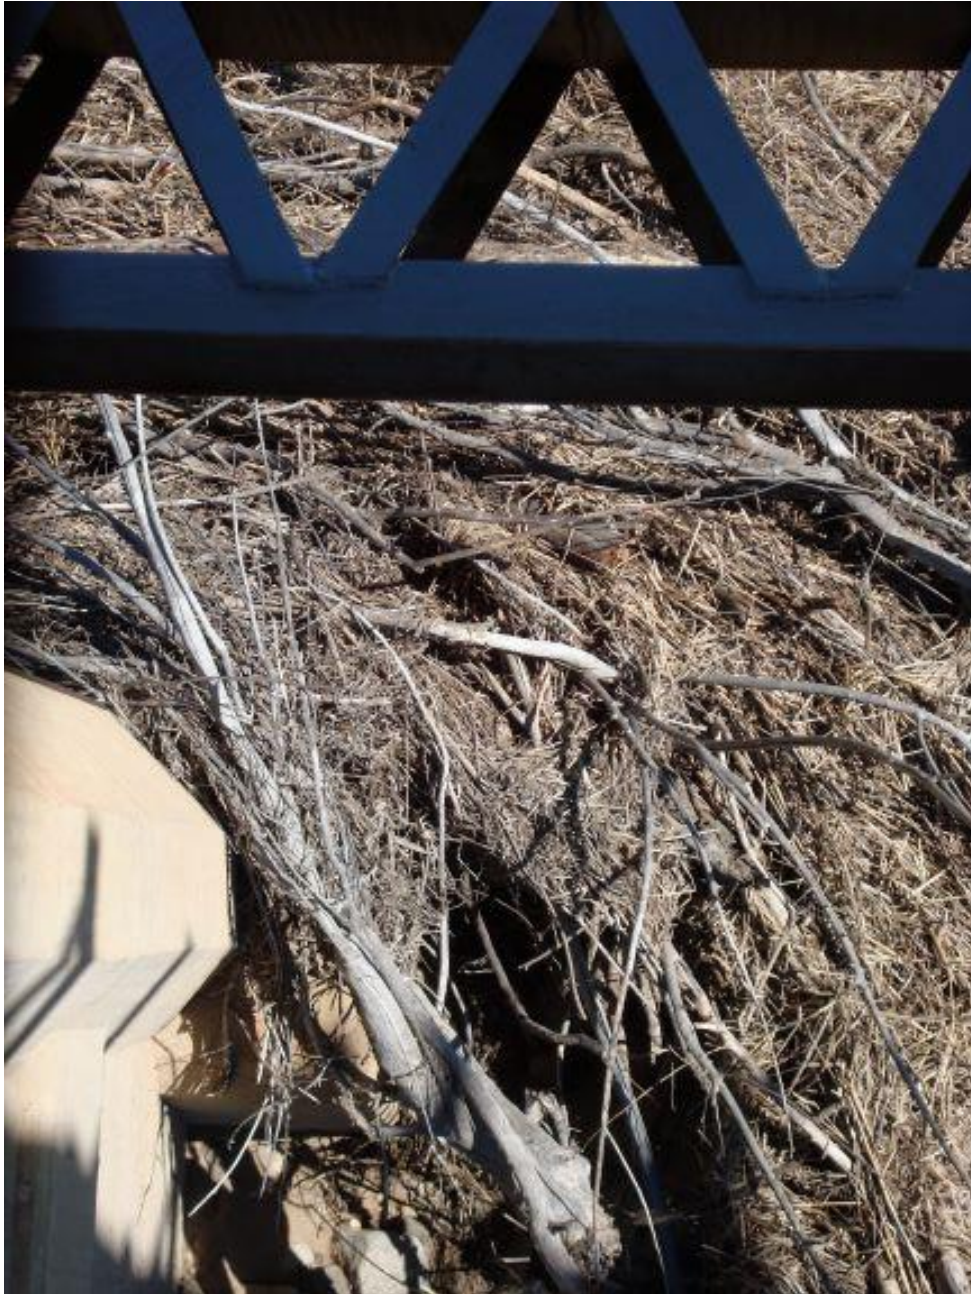
**Debris around a pier in the river bed.  
This illustrates the danger that destroyed the original bridge.  
Image: Owen Peake.**

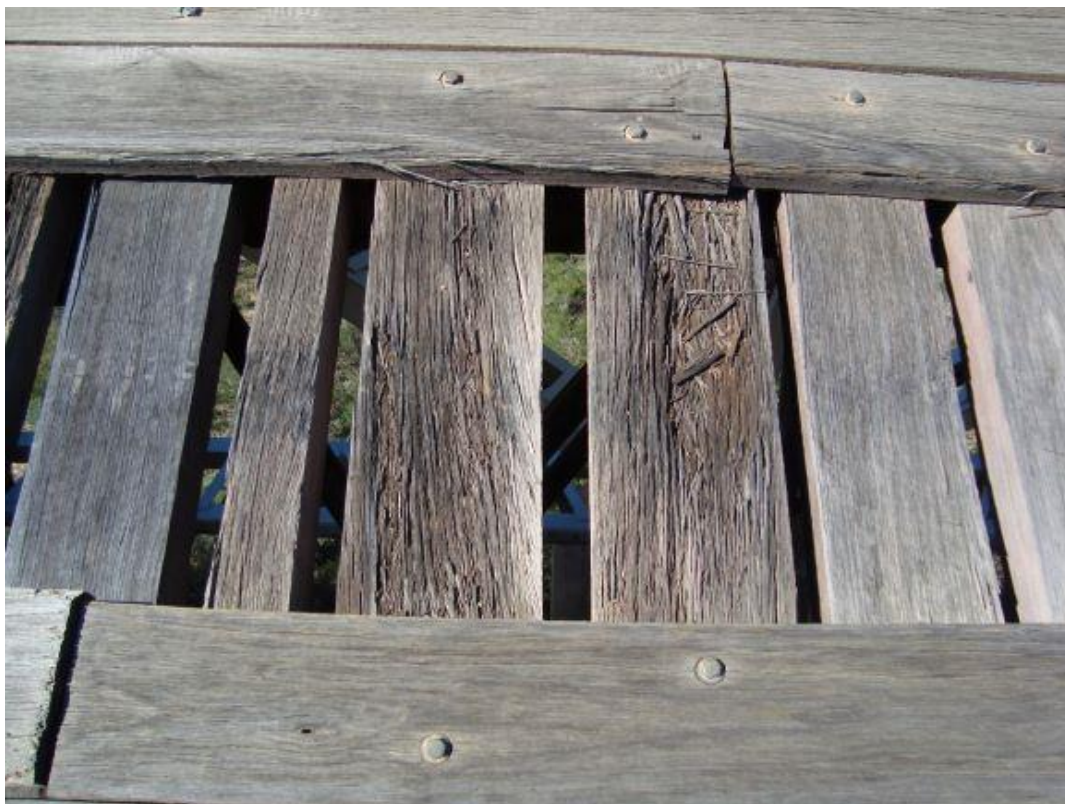
**Timber decking members (vertical) and running strips on McKillops Bridge.  
Image: Owen Peake.**

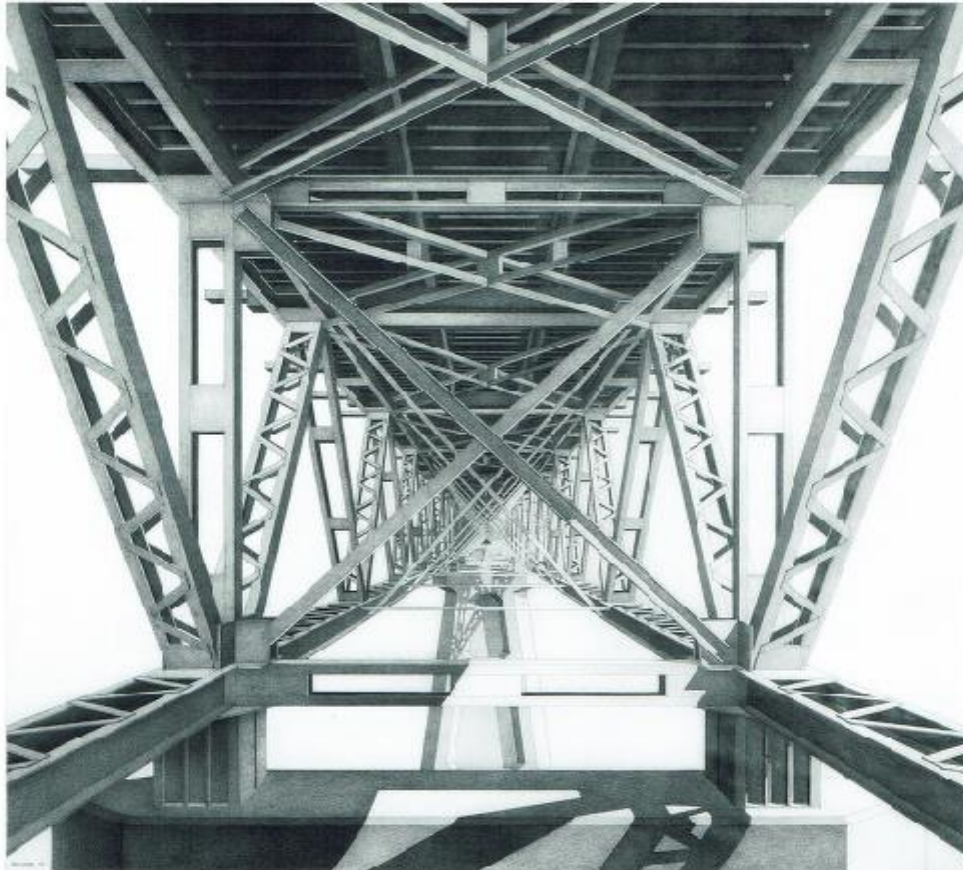
2. 570 x 570 mm, graphite pencil on vellum

**Drawing by Kevin Parker of McKillops Bridge looking along the bridge from the centre line and showing details of the steel trusses. All the members of the main trusses are fabricated by electric welding. Horizontal and vertical diagonal bracing of the trusses is visible. With permission from artist Kevin Parker.**

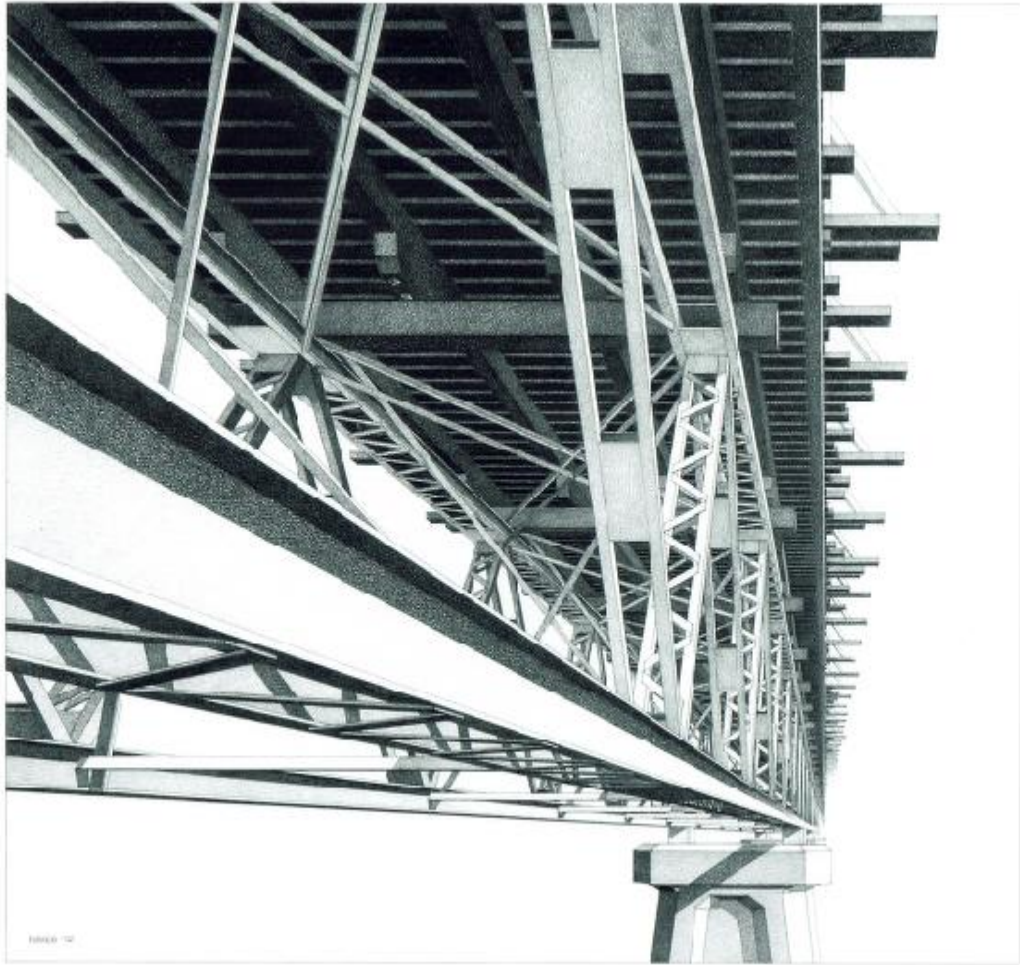
11.450 x 515 mm, graphite pencil on CA grain paper

**Drawing by Kevin Parker of McKillops Bridge showing details of the trusses and timber upper structure and how they are connected. The lowest member of the timber upper structure can be clearly seen. The transoms are square in section and extend just beyond the outside edges of the trusses. They are grey in colour in this drawing.**

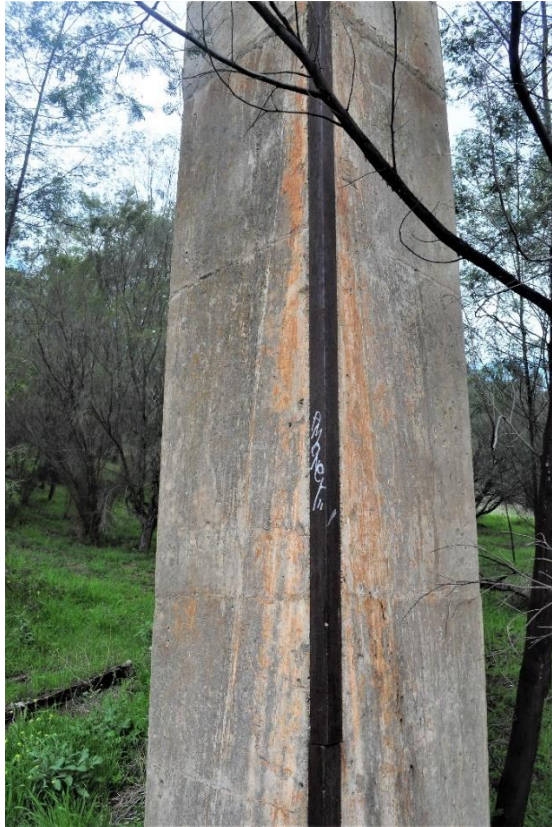
Steel angle set into the upstream face of a pier to help resist the impact of debris in the river during flood events. Note that the upstream edge of the pier has an included angle of about 90 degrees to assist water flow around it.

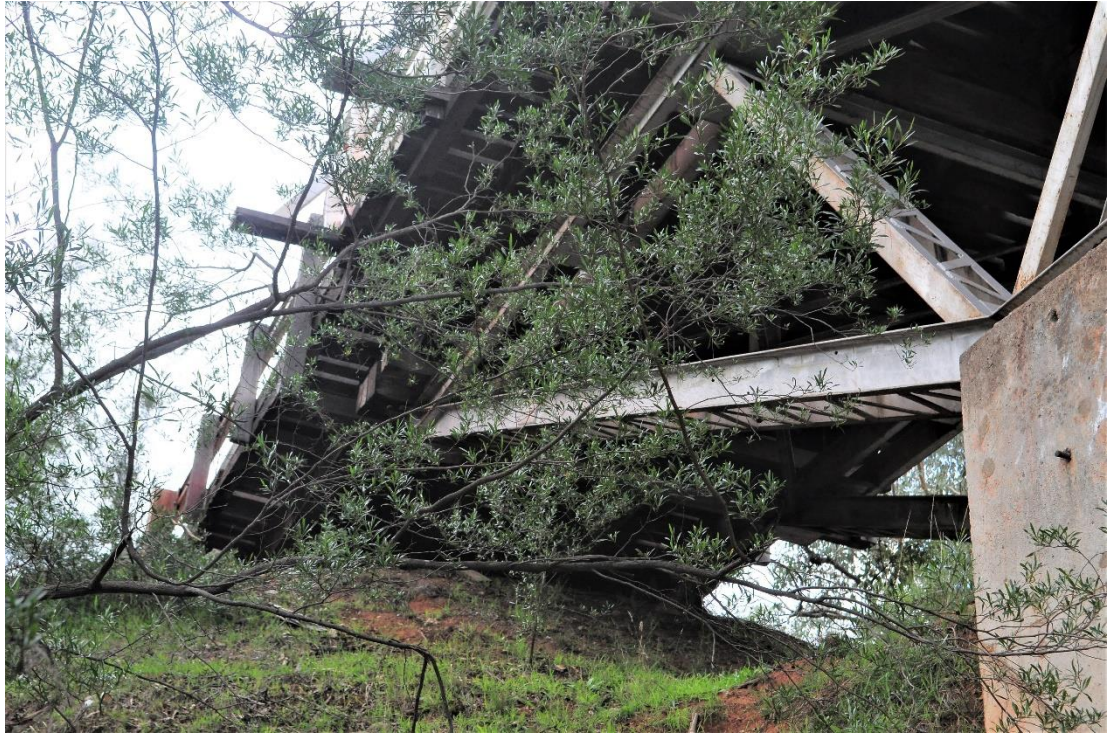
**Short cantilever section between the eastern abutment and the adjacent road.  
Image: Owen Peake.**

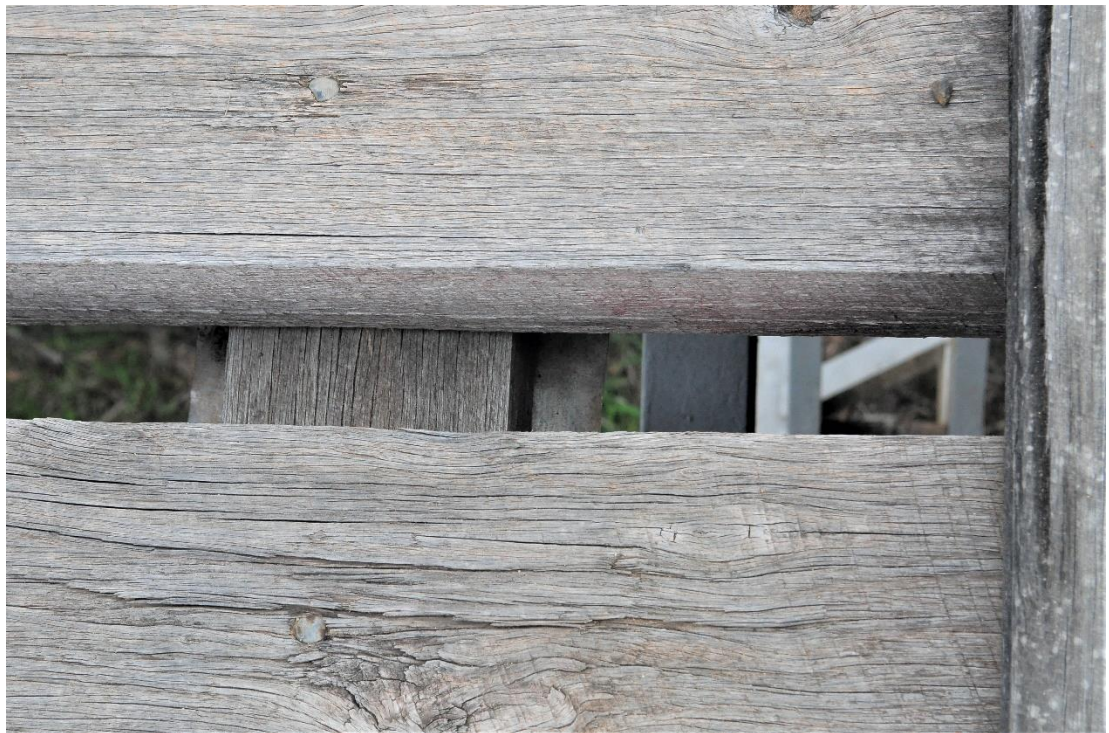
**Detail of deck over gap between decking timbers. Handrail is out of frame to the left. Running strip is at the right hand edge of the image. The longitudinal timber girder can be seen through the narrow space running up/down the image to the middle left and the top of the truss can be seen at the middle right inboard of the longitudinal girder timber. Image: Owen Peake.**

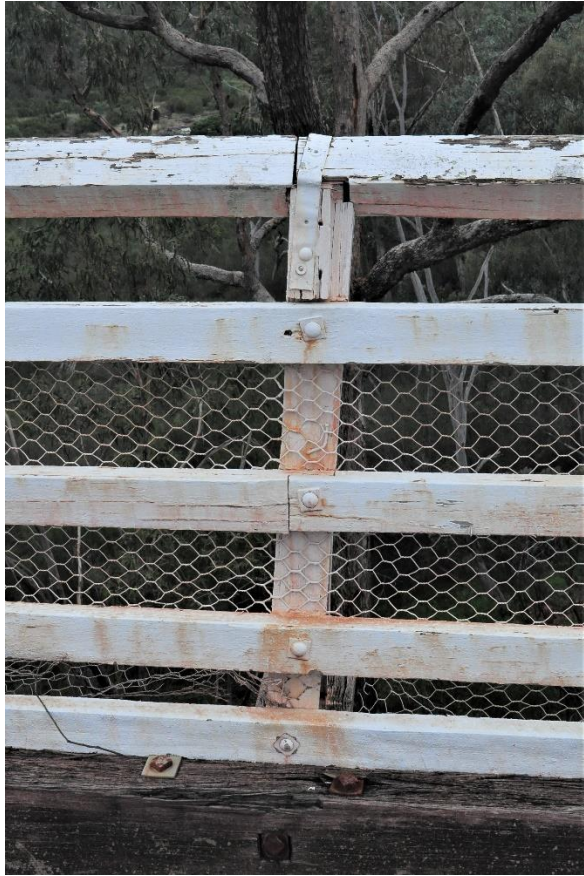
Detail of handrail looking from the deck directly at a handrail post. Note that there is a heavy top rail mounted diamond-style and four rectangular rails, closer together near deck level.

Wire netting has been used to further increase the security of the handrail.

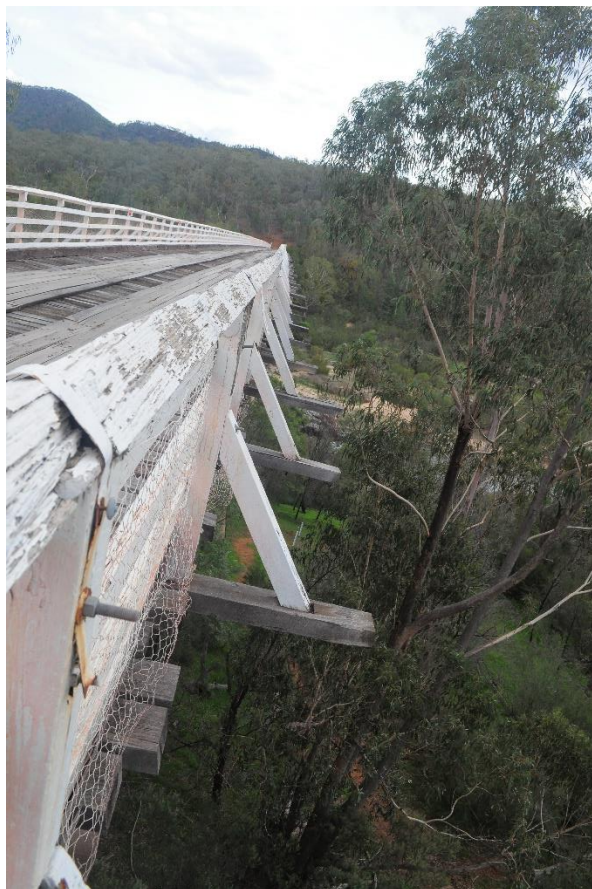
Looking along the handrail, just outside the roadway. The fixing of the top diamond-style handrail member can be seen using straps over the rail. The wire netting can also be seen.

The diagonal struts to support the handrail can be seen bolted to the handrail posts part way up and fitted into a recess and bolted in the extended decking timbers.
